OBSERVATION OF THE NEARSHORE WATER  
CIRCULATION OFF A SAND BEACH

JOHN F. BRENNAN  
RICHARD P. MEAUX

Submitted in partial fulfillment of the  
requirements for the degree of

1964

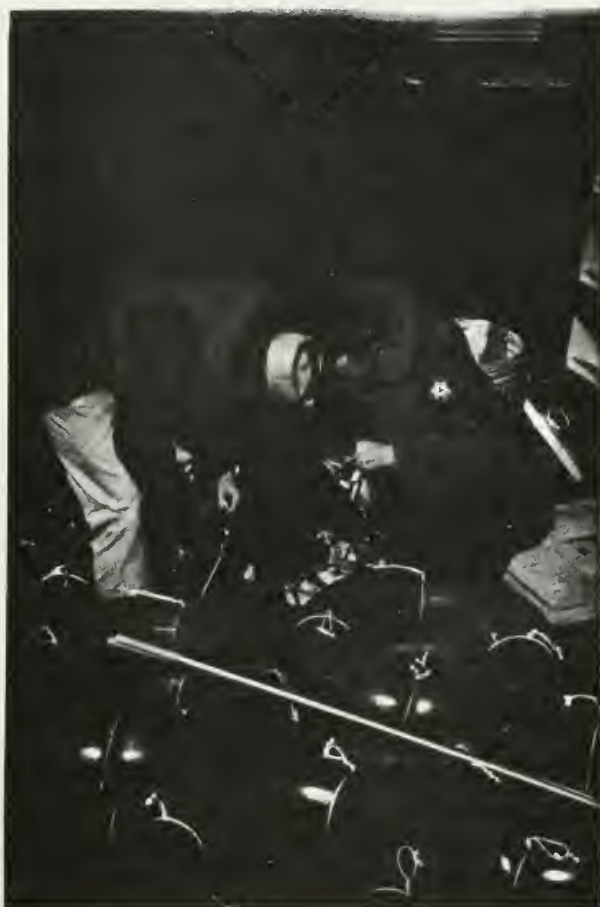
The float that was selected for the surveys was devised by the writers and is illustrated in Fig. 4. It consisted of two automobile innertubes lashed together, the lower one being water-filled and the upper one air-filled and painted to enable good visibility from the air. Dye-marker packets were attached to each float for added visibility. A 40-foot motor launch owned by the USNPGS was used to test the various floats, but it was not used in the surveys that followed because of the hazard of its getting caught in a breaker while launching or retrieving floats a short distance seaward of the surf zone.

Figure 4. Double Innertube Floats.

B. Double tubes: Two innertubes were lashed together, one on top of the other, with the top tube filled with air and painted for visibility and the bottom one filled with fresh water (Fig. 4). Dye-marker packets were attached to each double innertube float. The floats were observed to leave a well-defined trail of dye which not only gave an excellent means of locating the float in an aerial photograph, but also gave an indication of the track of the float with respect to the surface water motion.

Double innertube floats were selected for use in this study because of their durability and their visibility from the air, both in the surf zone and to seaward of it. Although balloons were not used, they are believed to have good potential as a float for tracing surface currents in open water seaward of the surf zone and further experimentation is recommended.

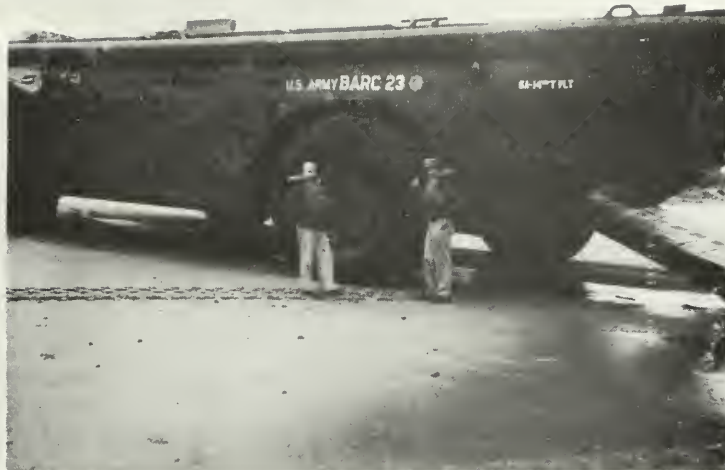
Figure 5. Army BARC.

In the actual surveys, an Army BARC was used to launch and retrieve the floats. The BARC, shown in Figures 5 and 6, is a large amphibious vehicle, 65-feet long and weighing 100 tons. Its ability to retrieve floats in the surf zone after it had launched them and to travel onto and along the beach made it an invaluable craft for the task.

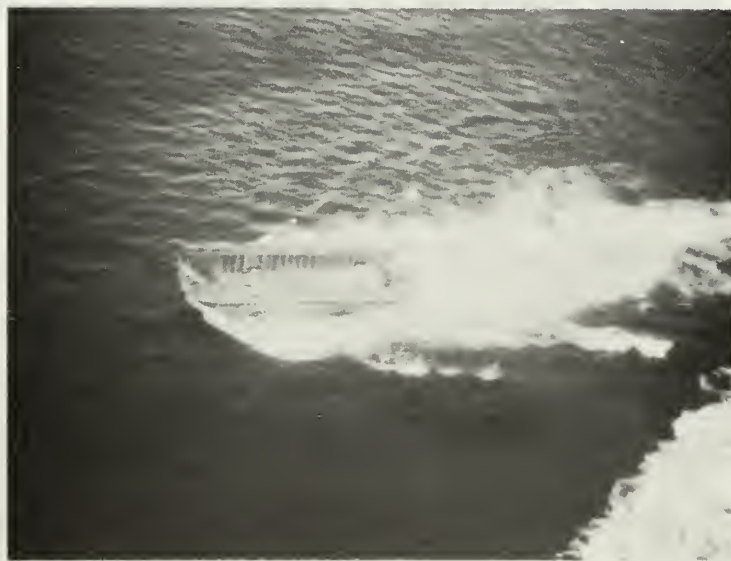
Figure 6. BARC Underway Just Seaward of a Breaker.

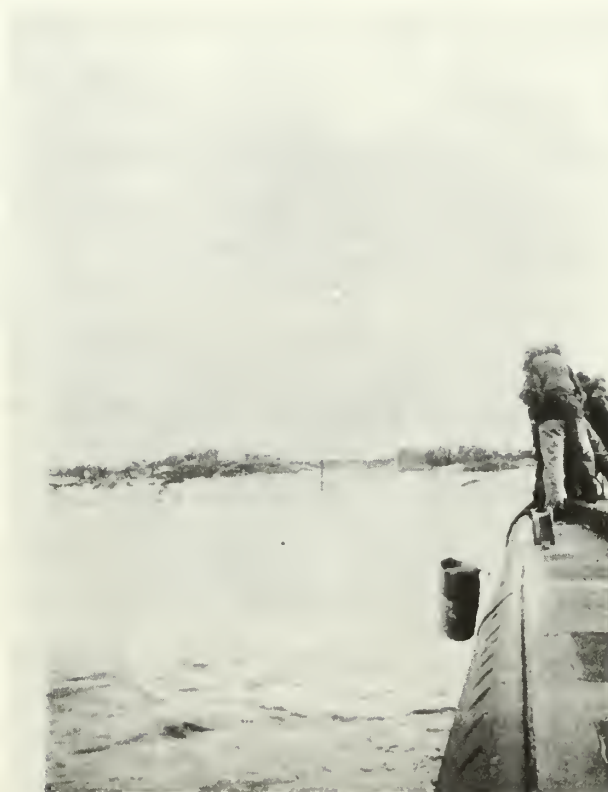
III. Weather balloons: A weather balloon filled with water was found effectively to form a unit of water which responds exactly to surface water motions while offering no sail area to the wind. Fluorescent dye was placed inside each balloon prior to filling to indicate leaks or position if the balloon was destroyed. The balloons proved very difficult to handle when full. The best system devised for filling and launching the balloons was to fill each in a 35-gallon trash can lined with kraft paper to avoid puncturing on the rough surfaces of the can, and to throw the can and balloon over the side (Fig. 23). The bottom of the can took the brunt of the impact and was retrieved by an attached line after the balloon floated free. When brightly painted the balloons were readily visible from the air. Prior to filling with water they were inflated with air and spray-painted various colors, although the results were inconclusive as to which color was best. The colors used were red, orange, yellow, metallic copper, metallic brass, metallic silver, metallic gold, and fluorescent red. Standard 300-gram weather balloons were used in these experiments and were filled with both fresh water and salt water.

Figure 23. Launching of a Weather Balloon Float .

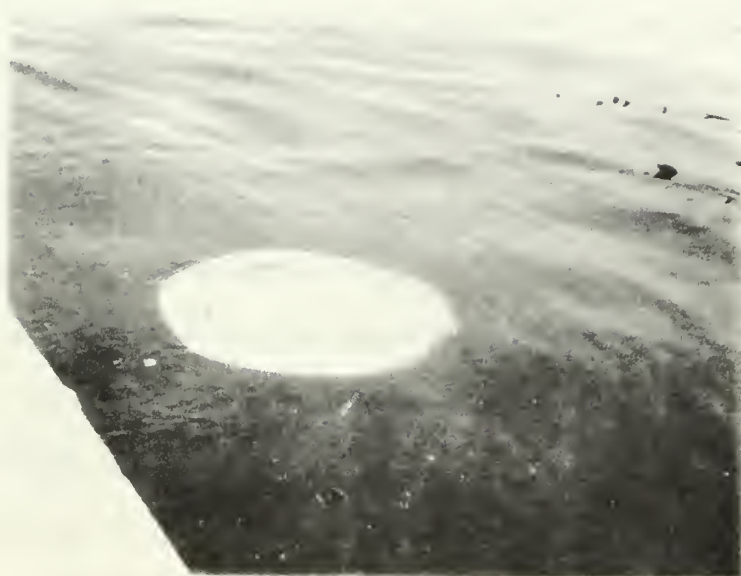
A. Fresh-water filled: Balloons were filled completely with fresh water.

a. Advantages: Buoyancy of the fresh water flattened the balloon out so that an area about two or three feet in diameter was exposed at the water surface, making the float clearly visible from the air at 1000 feet (Fig. 24). The balloon floated awash, unaffected by the wind, and did not break on contact with a rough surface.

b. Disadvantages: The balloons ruptured in a ten-foot surf although they worked well in a three-foot surf.

Figure 24. Fresh-water-filled Weather Balloon Afloat.
